Structural Analysis of a Five-Storey Reinforced Concrete Hospital Building: A Case Study of RSI NU Cakra Medika

Yoga Adi Saputra¹, Akbar Maulana^{2*}, Agung Kristiawan³, Revaldo Widi Purwanto⁴

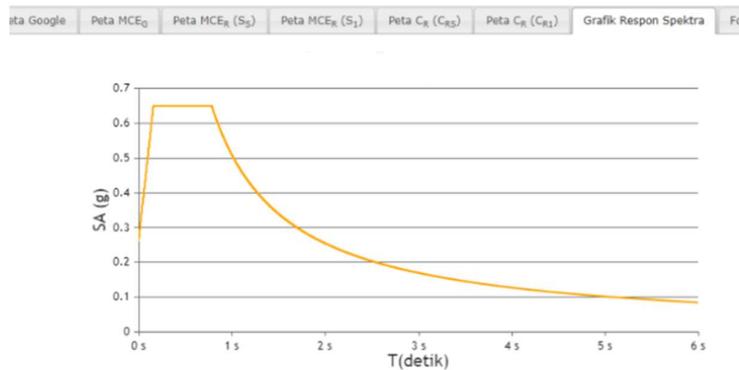
Figure 2. Spectrum response for Jepara area

The applied loads consisted of dead loads, live loads, and seismic loads. Dead loads included the self-weight of structural components and permanent non-structural elements, while live loads were assigned based on the functional use of hospital buildings. Seismic loads were determined in accordance with the relevant Indonesian seismic design provisions (RSA Cipta Karya), considering the building's location, site conditions, and importance category as illustrated in Figure 2. Load combinations were applied following SNI 2847:2019 to obtain critical internal forces and structural responses.

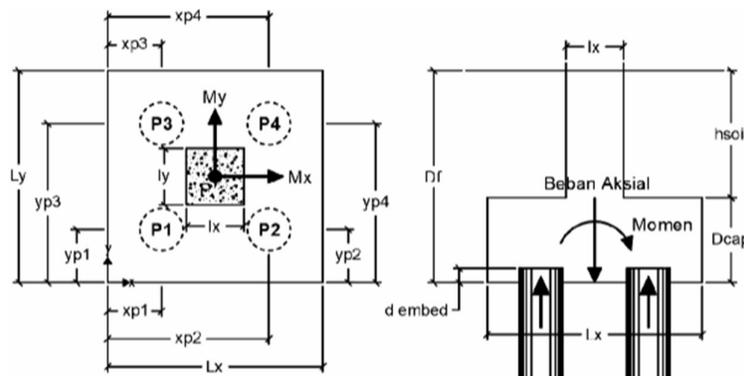
The foundation system employs driven pile foundations with a pile diameter of 50 cm and an embedment depth of 22 m. The illustration of foundation analysis are shown in Figure 3. The selection of pile foundations is based on subsurface conditions and the magnitude of structural loads. This foundation configuration is expected to safely transfer both vertical and lateral loads to deeper soil layers, ensuring overall structural stability. Table 9 provides summary of whole analyses of foundation, describing Pile Cap type, number of spun piles.

Figure 3. Foundation analysis
